Manhole Inspection Summary

Manhole # S41Y1_007MH

Insp Date: **6/24/08 11:25 AM**

Location Address: **700 E. Patapsco Ave.**

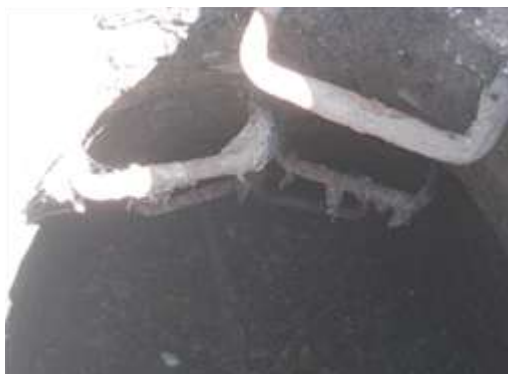
Steps Count: **5** Missing: **0** ☒ **Corroded**

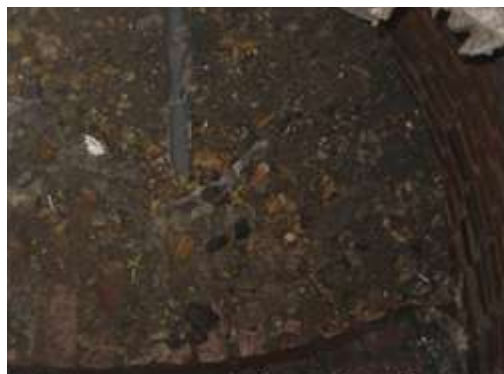
Defect 1

Debris on the bench.

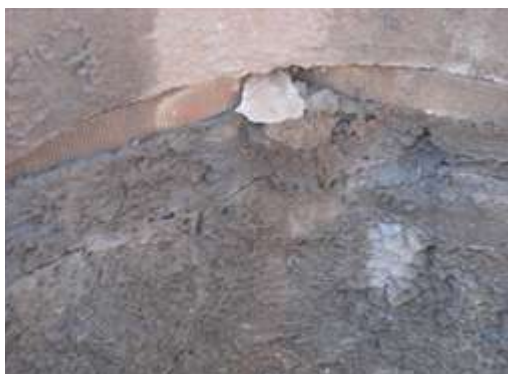
Defect 2

Condition: ☐ Sound ☒ **Cracked** ☐ Root Intrusion ☐ Loose Brick ☐ Deteriorated

Infiltration: ☐ None ☒ **Joint** ☐ Cracks ☐ Mortar ☐ Roots ☐ Wall

Cracked Chimney and infiltration.

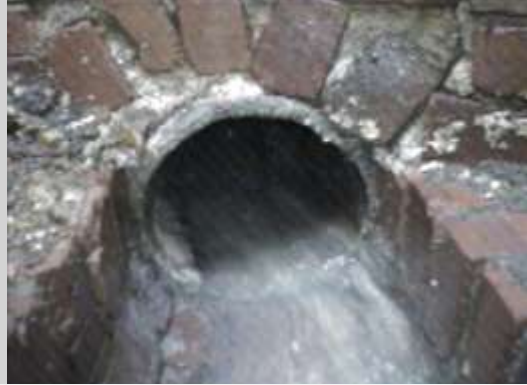
12 O'Clock Outflow

8 in. Circular Gravity Sewer
Pipe Out @ 12 O'Clock

Pipe Height: **8.4** (in.) Rod and Bar (Angled)
Pipe Material: **Clay** ☐ Pipe Lined
Invert Depth: **11.14** (ft.) Flow Characteristics: **Fast**
Deposits: ☒ None ☐ Mud ☐ Sludge ☐ Debris ☐ Grease
Silt Depth: (in.) Deposits Extent:
Infiltration: **None** Pipe Seal Cond: **Cracked**

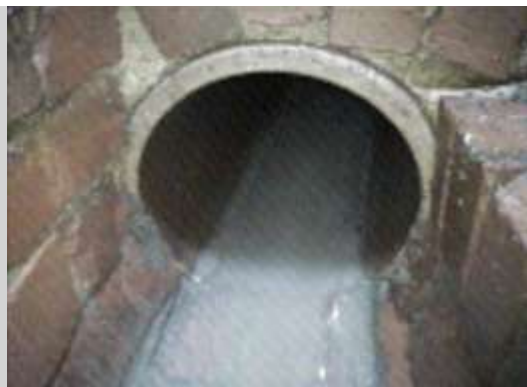
7 O'Clock Inflow

8 in. Circular Gravity Sewer
Pipe In @ 7 O'Clock

Pipe Height: **8.4** (in.) Rod and Bar (Angled)
Pipe Material: **Clay** ☐ Pipe Lined
Invert Depth: **10.68** (ft.) Flow Characteristics: **Fast**
Deposits: ☒ None ☐ Mud ☐ Sludge ☐ Debris ☐ Grease
Silt Depth: (in.) Deposits Extent:
Infiltration: **None** Pipe Seal Cond: **Sound**
